# CASE STUDY

UTILISING IOT TECHNOLOGY TO  
VALIDATE RETROFIT INTERVENTIONS

A CASE STUDY EXPLORING  
HOW THE DATA FROM  
HOMELINK ENVIRONMENTAL  
SENSORS CAN BE USED TO  
VALIDATE SUSTAINABILITY  
INTERVENTIONS.

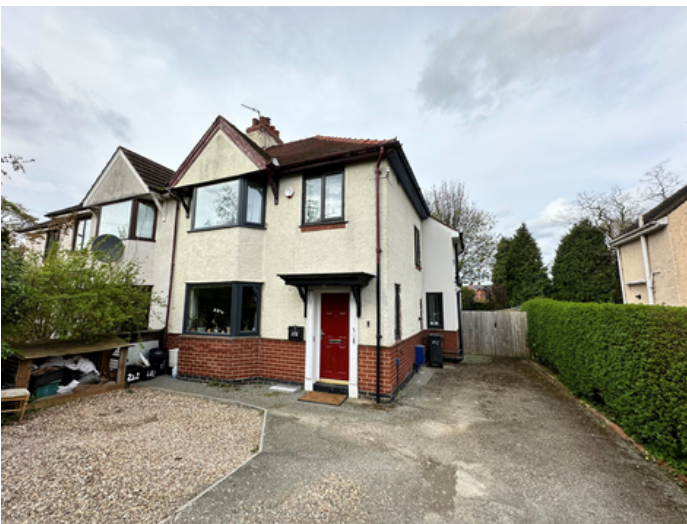
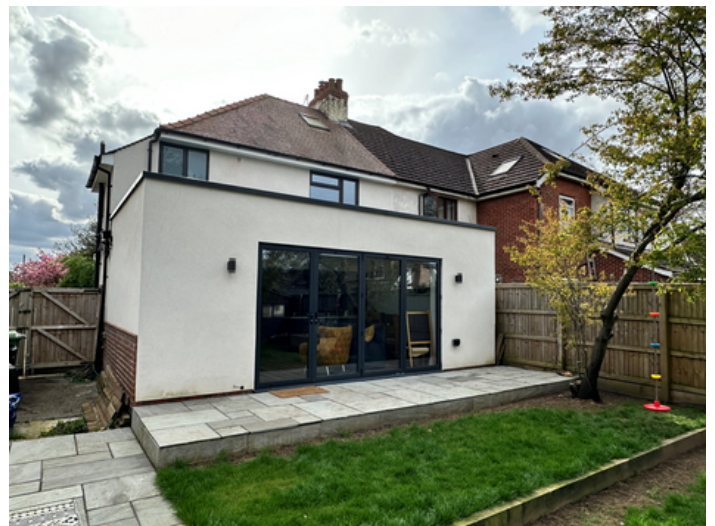
The property at the centre of this case study is a 1930's semi-detached house in York. Constructed with solid brick, the original render to the front and side of the property was inefficient, while the rear extension, covered in cracked and discoloured monocouche rendering, further contributed to heat loss.

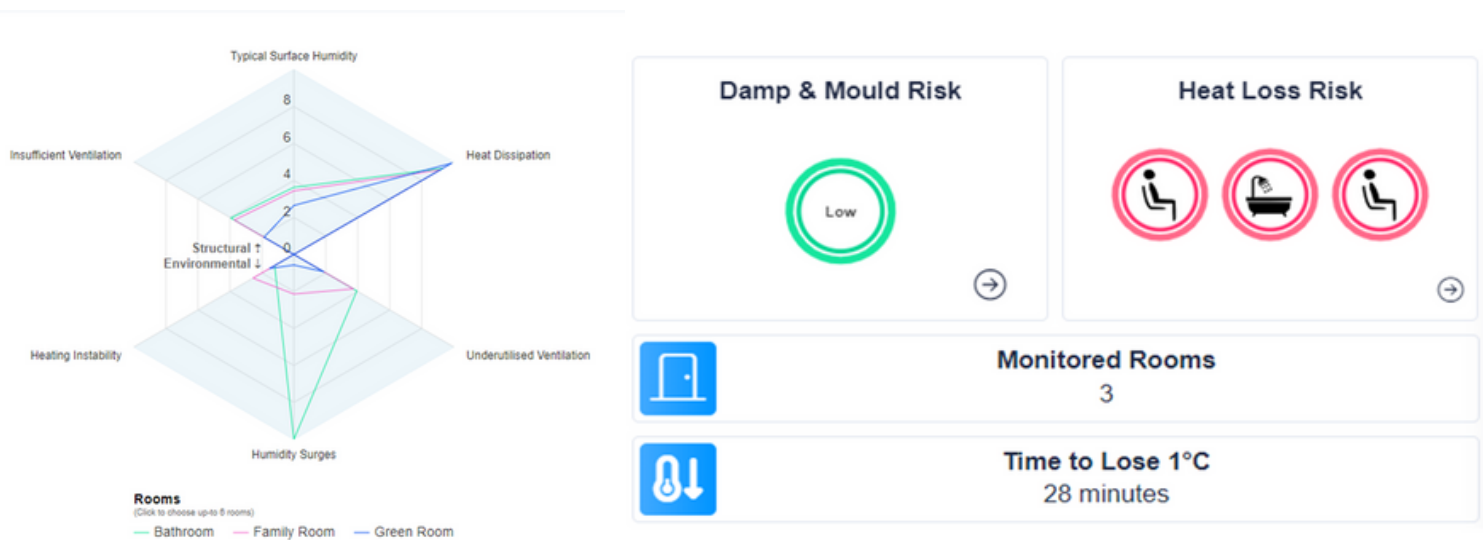
In addition to the EPC data, HomeLINK Environmental Sensors were installed in the property 12 months prior to the intervention work. These sensors collect temperature, humidity, and CO2 data at 15-minute intervals to capture a detailed picture of the property's indoor environment. The collected data was uploaded to the HomeLINK portal, where it was analysed using innovative algorithms and presented back to the user with actionable insights about thermal efficiency, ventilation and humidity.

The data collected from the sensors echoed the EPC, identifying that the property had a high heat loss risk across the 3 rooms monitored: the bathroom, family room and green room. Additionally, the average Time to Lose 1 degree (TTL) of 28 minutes indicates a quicker rate of heat loss. The actionable insights show that heat dissipation is an issue across all monitored rooms and, when compared to humidity and ventilation, is the biggest problem in the home. This reflects the lack of insulation in the walls, confirming the assumptions in the EPC.

The TTL value can be used to provide a comparison of heat loss across different homes. It is calculated by utilising both internal and external temperature conditions, meaning we have the ability to understand how quickly a room is losing heat to the outside world. With machine learning models, the relative impact external temperatures have on internal temperatures - and the impact internal temperature have on each other - can be captured. This allows us to produce an accurate prediction of the temperature a room will be cooling down to.

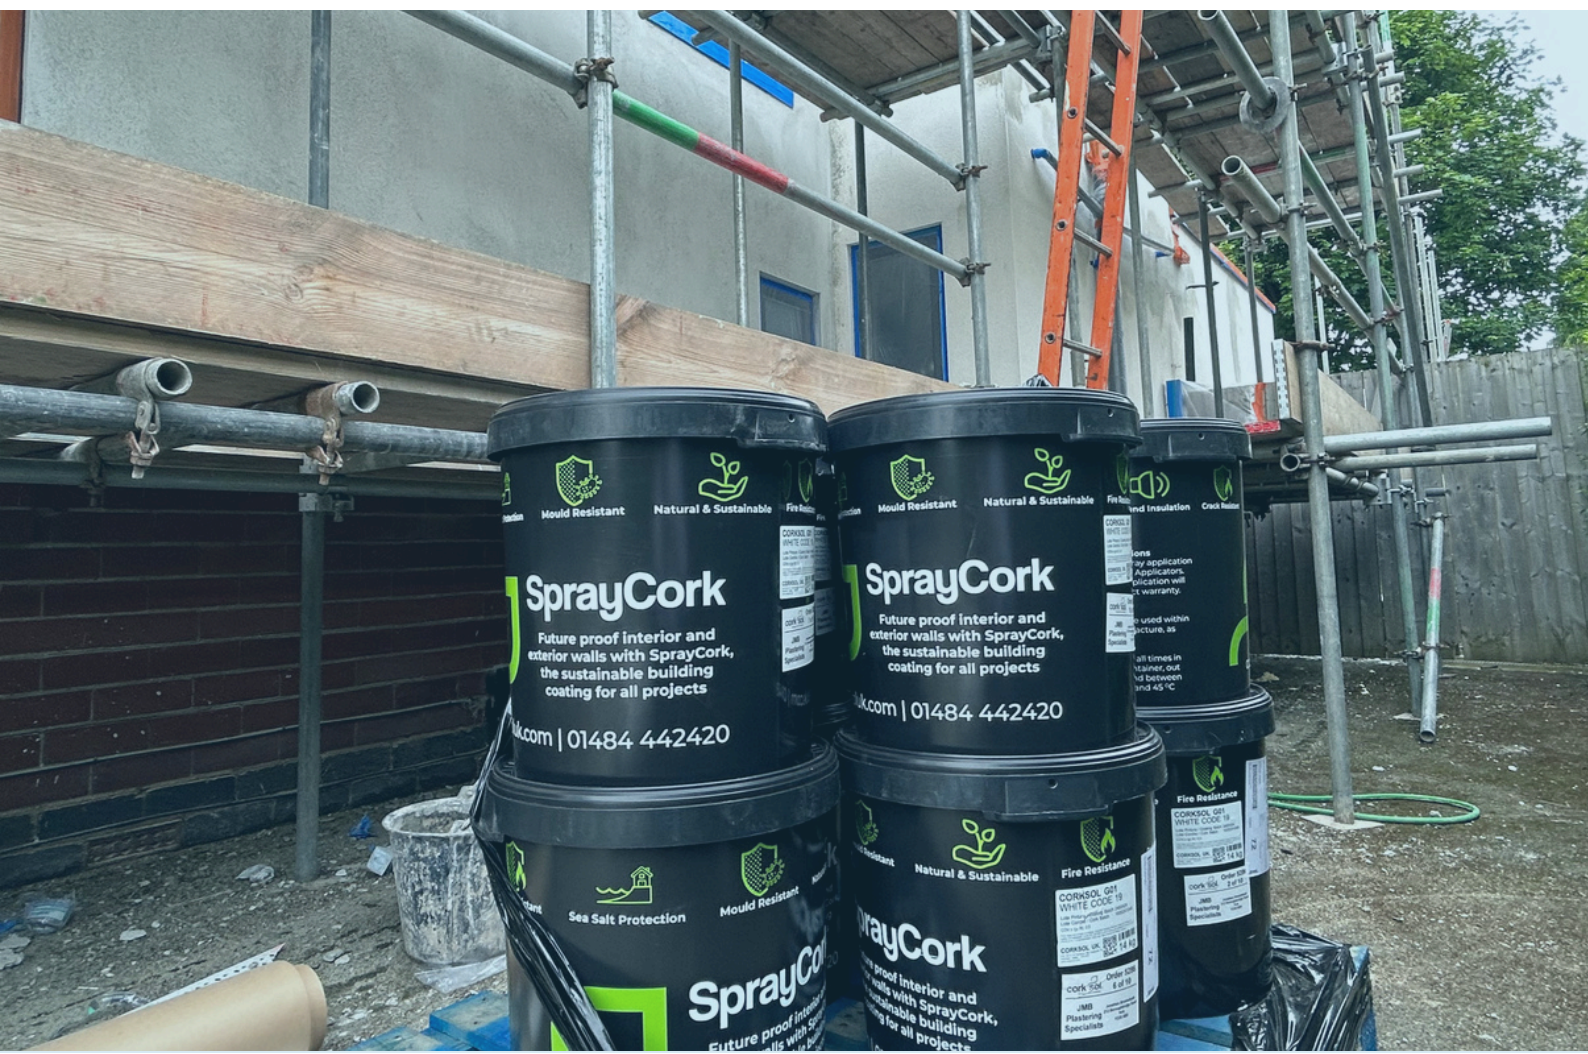
The decision was made to try a new innovative cork-based render system. CorkSol offered a perfect solution as their exterior wall coatings use a thin layer of spray-applied natural cork, one of the world's most sustainable natural resources. It is highly water and weather-resistant, providing a stylish and modern finish that is natural, eco-friendly, and low maintenance as no repainting will be required.

In addition, and more importantly, the natural thermal performance of the cork in CorkSol can reduce heat loss by up to 30%. The coatings are seven or eight times more insulating than traditional lime or sand renders, with a total installation thickness of 6 - 8mm. In this case, it meant that the existing render system could be hacked off and replaced without coving the lower brickwork or moving the windows.

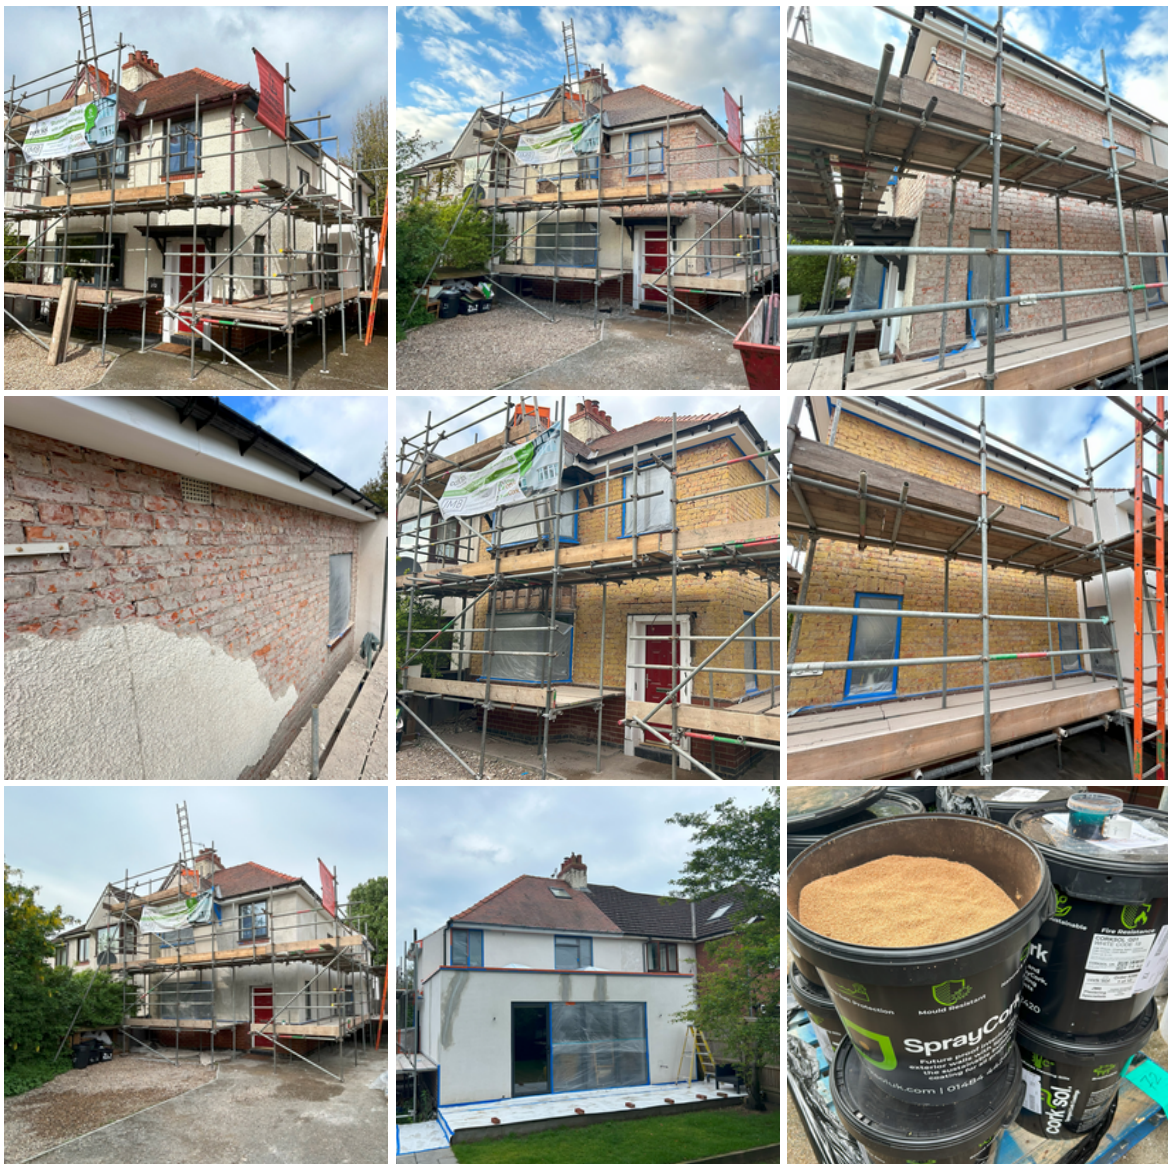
The installation was carried out by JMB Plastering Specialists, a well-established, CorkSol UK-approved applicator. The process involved removing all the existing render, investigating the area and tying any cracks in the brickwork. The brickwork was then sealed and primed before a new scratch coat was applied. There was no need to remove the existing monocouche as this could be sprayed straight over the top. All the windows, fascia and soffits were then taped up, ready to be sprayed.

The spraying was completed within a few days, and the home looked fantastic once complete. However, the crucial question was yet to be answered; could the claim of reducing heat loss by up to 30% be validated?

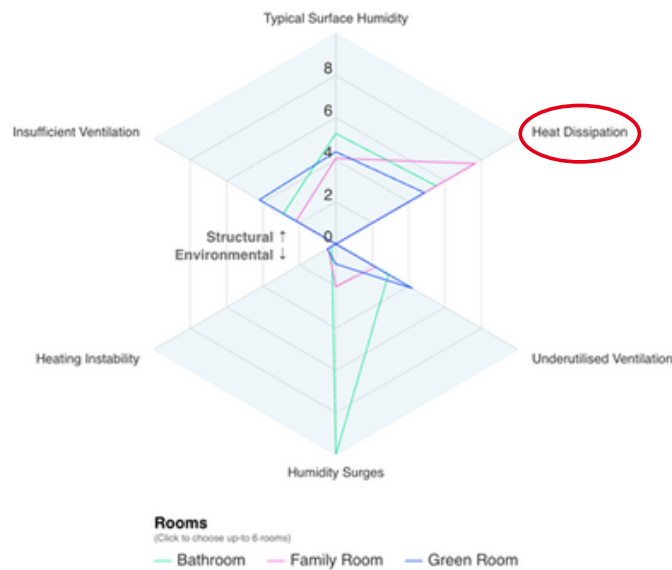
To evaluate the effectiveness of the CorkSol solution, the property was monitored for two months following the intervention. The results, including Time to Lose 1 Degree and Heat Loss Risk, were then compared to pre-intervention data, both of which were available through the HomeLINK dashboard.

The results showed a significant improvement in the property's energy performance. Heat loss risk had changed from high across all three rooms to medium in 2 and low in 1. In line with this, the TTL 1 degree had increased from 28 minutes to 53 minutes, a huge increase of 25 minutes. This demonstrated a huge improvement in the energy efficiency of the home.

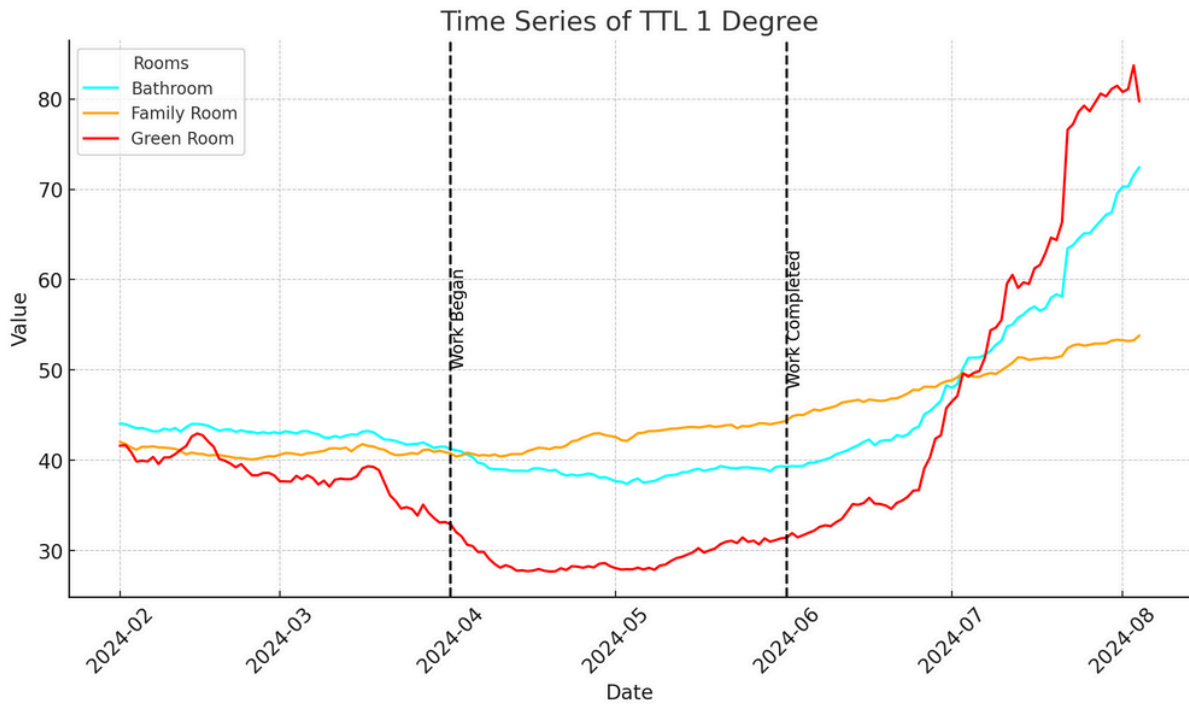
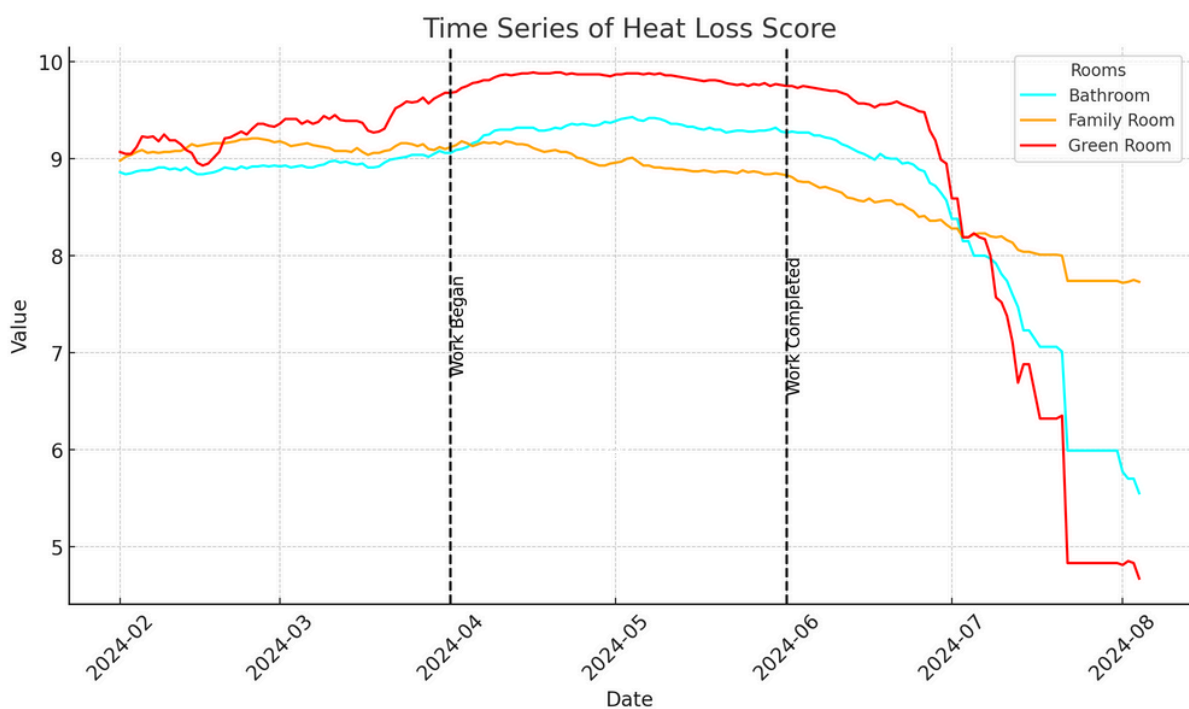
Comparing the changes to TTL and heat loss scores over time demonstrates the positive impact the intervention has had. In addition, heat dissipation improved across all rooms, with more than a 50% improvement in the 'Green Room.' This suggests that CorkSol has doubled the fabric's ability to retain heat within the building, with a notable impact in this room due to the presence of a poorly insulated bay window. Ongoing monitoring by the landlord will be essential to assess the long-term impact of the intervention.
