## **Comprehensive analysis of SprayCork on solid-wall properties: permeability, thermal performance, and damp protection**

Robert Shawdale

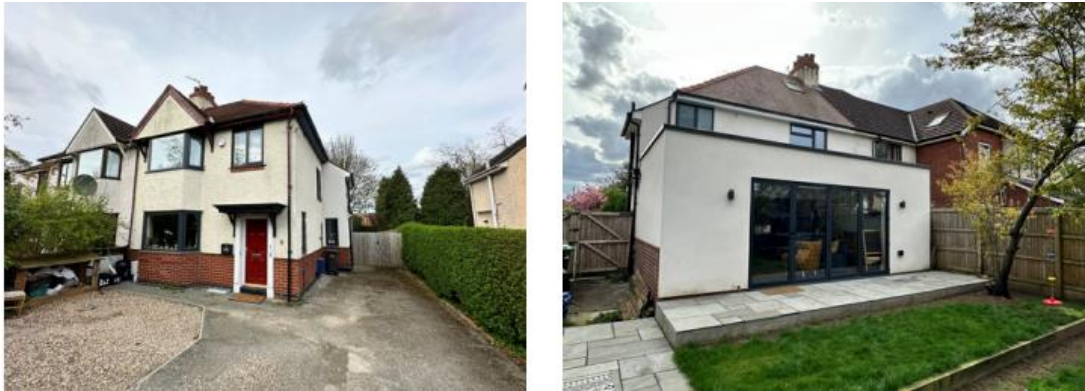
The property at the centre of this case study is a 1930's semi-detached house located in York. Constructed with solid brick, the original render to the front and side of the property was insufficient, whilst the monocouche render on the rear extension was cracked and discoloured, leading to further heat loss (see figure 1 for a photo of the front and side, as well as the rear of the property).

*Figure 1. Front and side (left), as well as the rear (right) of the property in this case study.*

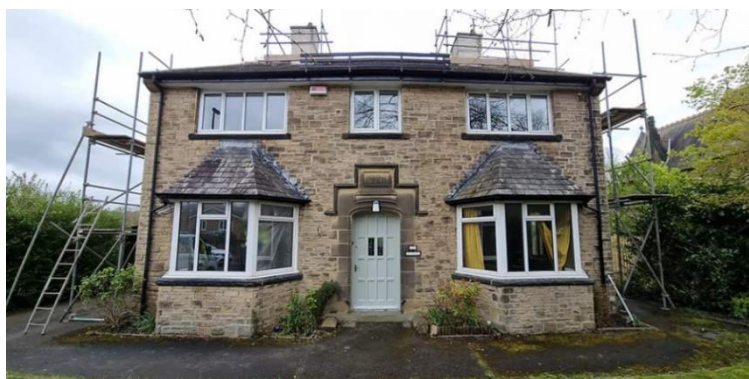
The property at the centre of this case study is a 1920's detached property (vicarage) located in Sheffield. Constructed with solid stone and no cavity, the property in question had been awarded a poor EPC rating and thus needed a solution which could address this whilst also having a sympathetic appreciation of the building type, heritage, and existing features. See figure 2 for a photo of the front elevation of the property.

Figure 2. Front elevation of the property in the case study.

As traditional insulation systems would require the removal and reinstallation of structural features, it was decided that SprayCork would be the optimal choice in terms of improving the energy efficiency of the property. See figure 2 for a photo of the front elevation of the property.
